The Oklahoma City Bombing:

IMPROVING BUILDING PERFORMANCE
THROUGH MULTI-HAZARD MITIGATION

In May 1995, the Federal Emergency Management Agency (FEMA) deployed a Building Performance Assessment Team (BPAT) composed of American Society of Civil Engineers (ASCE) and Federal Government engineers to investigate damage caused by the malevolent bombing of the Alfred P. Murrah Federal Building.

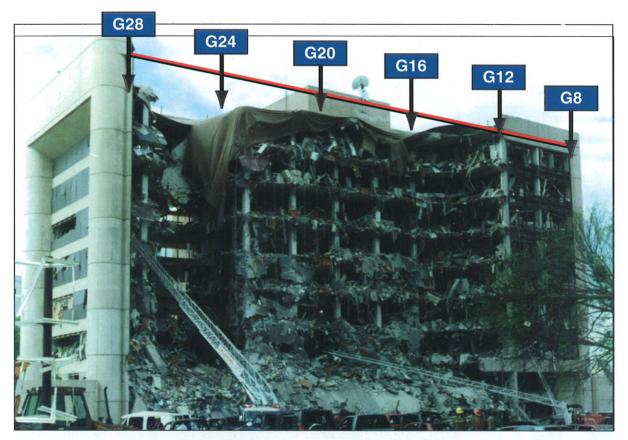
Major structural damage and building collapse occurred at the north side of the Murrah Building, which faced the blast (Figure 1-14). Here, most of the north half of the rectangular footprint, between Columns G12 and G28 (except for the extreme west end), extending 35 feet into the building, collapsed. Three columns (G16, G20, and G-24) supporting the third-level transfer girder were destroyed. The destruction of these columns triggered the progressive collapse of floors above. In addition, between Column Lines 20 and 24 (a length of 40 feet), the collapse extended the full 70-foot width of the building (to, but not through, the south wall). Roughly half of the occupiable space in the nine-story portion of the building collapsed.

Figure 1-14 Damage to north and east sides of Murrah Building.

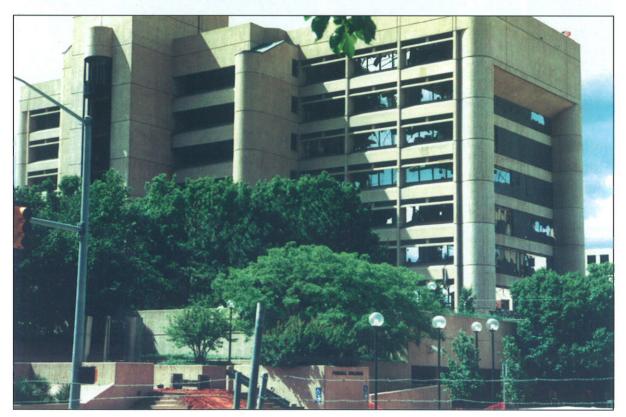
While the north face of the building sustained the brunt of the effects of the blast, structural damage to the remaining exposures was limited, as illustrated in Figures 1-15 and 1-16.

Figure 1-15 Damage to southeast portion of Murrah Building.

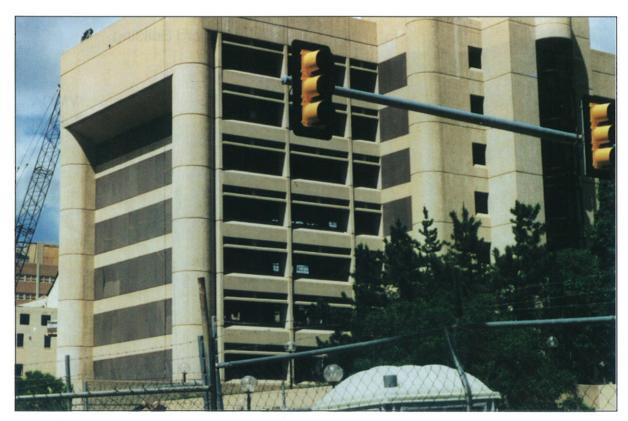
Figure 1-16 Damage to southwest portion of Murrah Building.

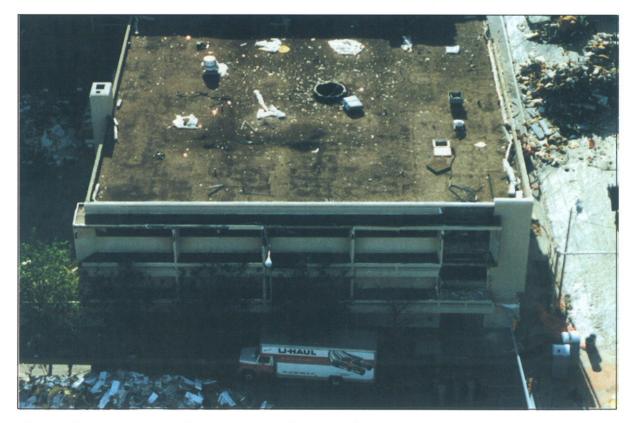
The Water Resources building, shown in Figure 1-17, is located close to the center of the blast. The exterior walls, roof slab, and interior of this building incurred significant damage. As can be seen in Figure 1-17, the windows were blown inward.

Figure 1-17 Damage to Water Resources building, looking east.

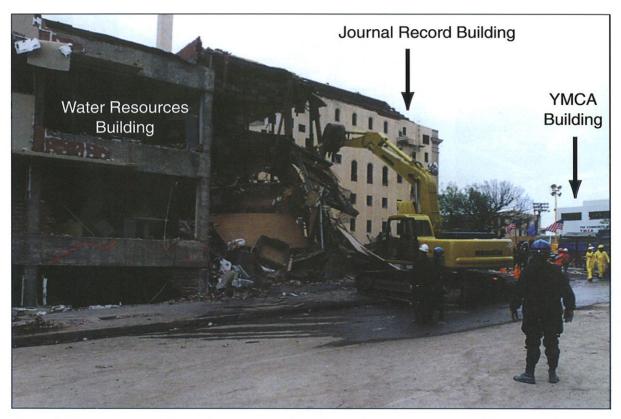
Figure 1-18 Damaged Water Resources building, Journal Record building, and YMCA building, looking northeast.

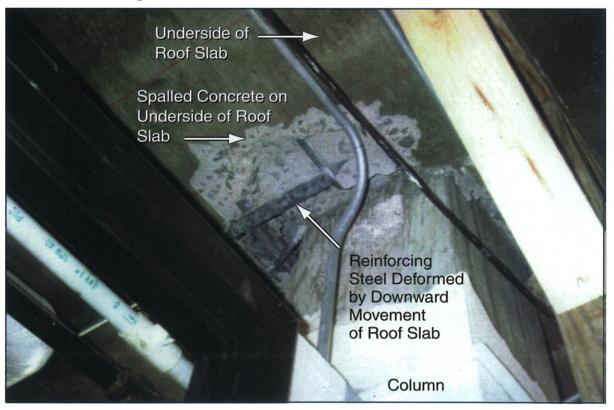
By far the most severe observable damage to the building was to the concrete roof slab. Here, the positive or downward loading of the blast pressure caused not only flexural cracks at the underside of the slab, but shear "punching" of the slab at interior columns. This is evident in the consistent spalling at the underside of the roof slab at interior columns (see Figure 1-19).

Figure 1-19 Damage to underside of roof slab in Water Resources building.

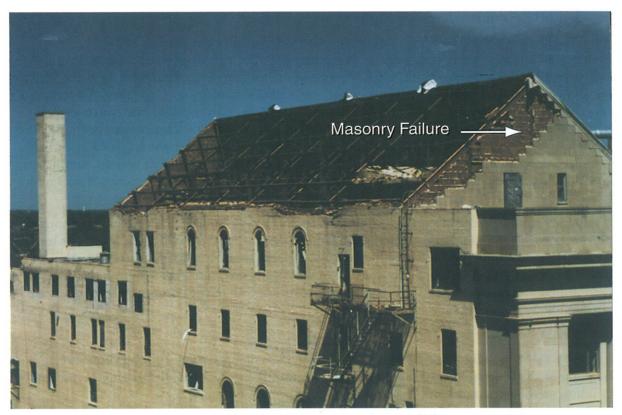
The Journal Record building, located due north of the nine-story portion of the Murrah Building, sustained significant damage to its exterior skin. The steeply pitched concrete roof panels facing the blast, most windows, and small portions of the masonry were destroyed. As in the Water Resources building, windows were blown inward and exterior masonry sections failed outward. In a reaction similar to that of the exterior skin of the Water Resources building, the concrete roof panels disengaged from the purlins in a "rebound" motion due to the low-pressure portion of the blast wave in combination with the rebound of the purlin/truss support system (see Figure 1-20). Localized rebound of each panel spanning the purlins, combined with other actions, may have contributed to disengagement of the roof panels. Steel roof purlins, spanning between steel roof trusses, exhibited visible evidence of yielding in the form of large permanent distortions.

Figure 1-20 Journal Record building – damage to roof on south side and masonry failure on east side.

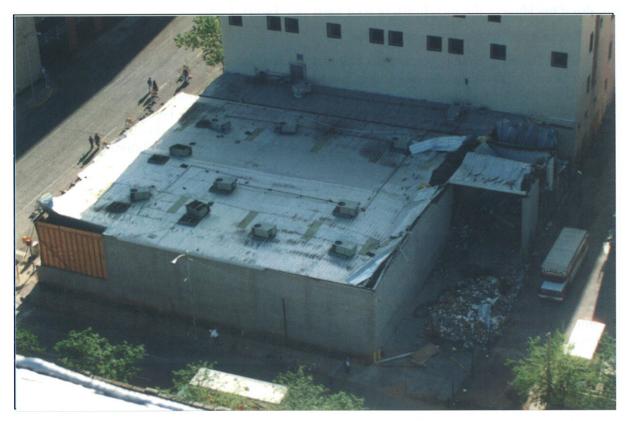
A one-story light-metal steel building just west of the main Journal Record building housed the presses. This building, referred to as the Journal Record Annex (see Figure 1-13), was badly damaged, sustaining severe deformations of roof and wall members (see Figure 1-21). Also, an unreinforced masonry wall on the north side of the Annex was damaged. This wall was quickly demolished and removed to reduce the hazard to workers. All of the damage to the Annex was attributable to blast effects.

Figure 1-21 Damage to roof and walls of one-story light-metal steel building (Journal Record Annex) on west side of main Journal Record building.

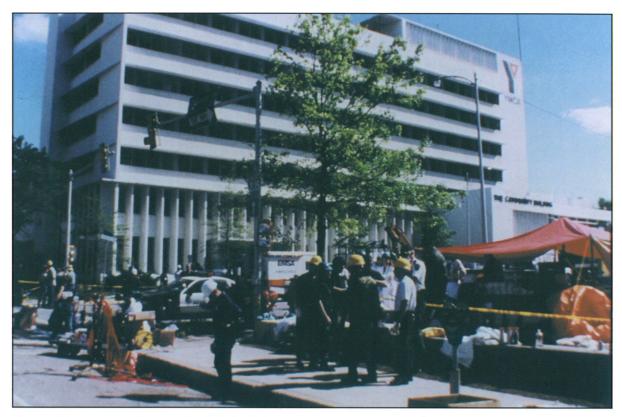
The YMCA building (see Figure 1-22) sustained less damage than the Water Resources building or the Journal Record building. However, with few exceptions, the glazing of the YMCA building was blown inward and destroyed.

Figure 1-22 South face of YMCA building.

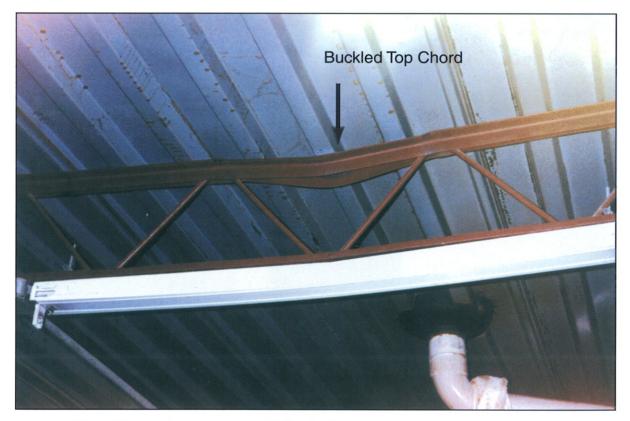
Structural damage to a light-metal roof system that had been added was visible at a few locations. This damage was due primarily to the downward force on the roof, which caused localized buckling of the top chords of roof joists (see Figure 1-23).

Figure 1-23 Bar joist in upper story of YMCA building.

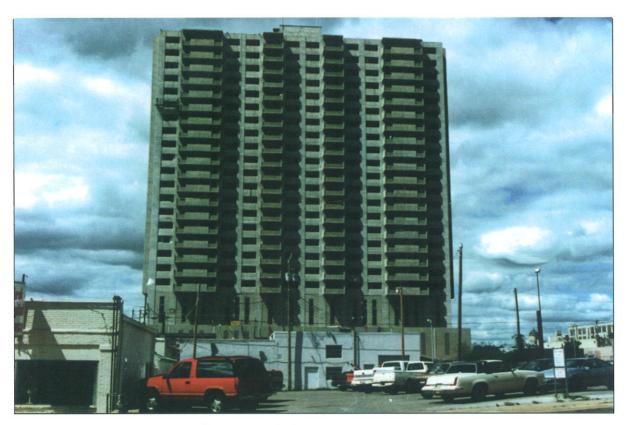
In the Regency Towers Apartments building, located about one block from the blast, further from the blast than the aforementioned buildings, all of the windows were destroyed (see Figure 1-24). There was no structural damage to this 1960's vintage reinforced concrete building. However, damage in the building at the air supply/exhaust system (see Figure 1-25) showed that the blast effects propagated through the mechanical ducting system and into the building. Also, some gypsum wallboard and stud partition walls were blown over inside the building.

Figure 1-24 Regency Towers Apartments building.

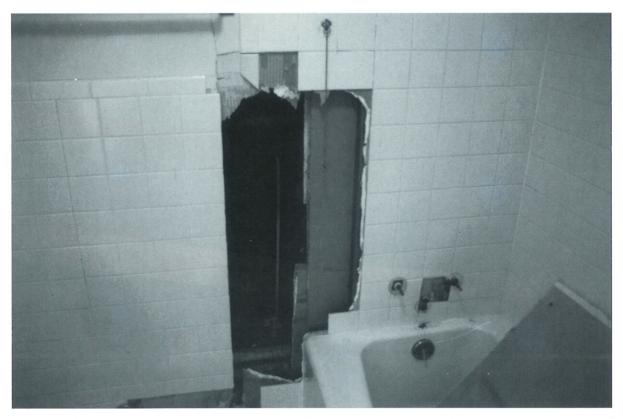
Figure 1-25 Damage to utility shaft of Regency Towers Apartments building.

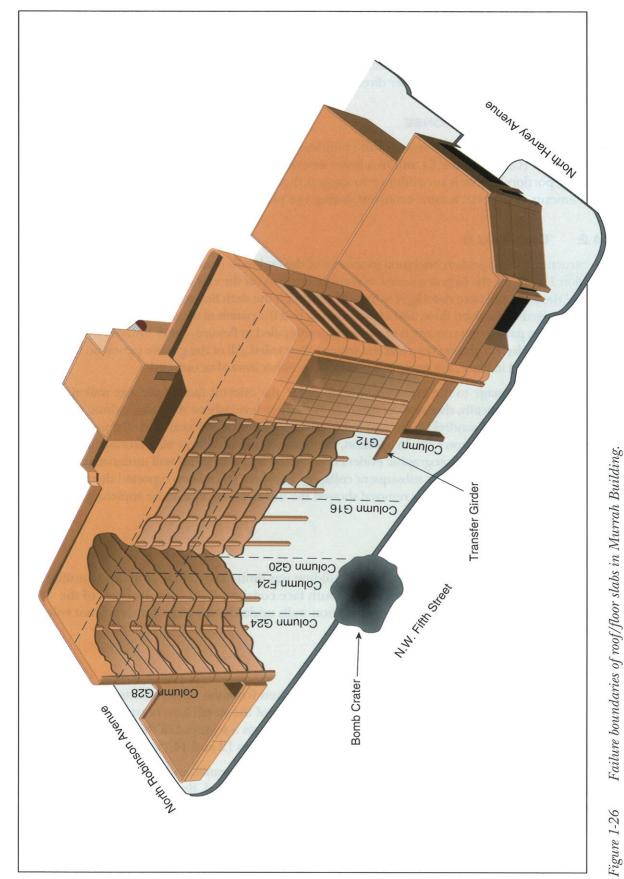
Observed failure boundaries for the floor slabs and roof slab are shown in Figure 1-26. All floor and roof panels between Column Lines 12 and 28 and Column Lines F and G failed, either partially or completely. In addition, with the loss of Column F24, all floor and roof panels between Column Lines 22 and 26 and Column Lines E and F also failed. Finally, floor panels on the second and third floors failed between Column Lines 18 and 22 and Column Lines E and F. In summary, out of a total of 180 floor and roof panels at the second floor and above, 112 failed either partially or completely.

Damage to the north face (Column Line G) resulted from the direct effects of blast and from the subsequent progressive collapse. Total collapse of the north face occurred from Column Line 12 to Column Line 28. The only exception was a segment of the transfer girder (third floor) which remained in place between Column Lines 12 and 14 (see Figure 1-26).

Failure boundaries of roof/floor slabs in Murrah Building.

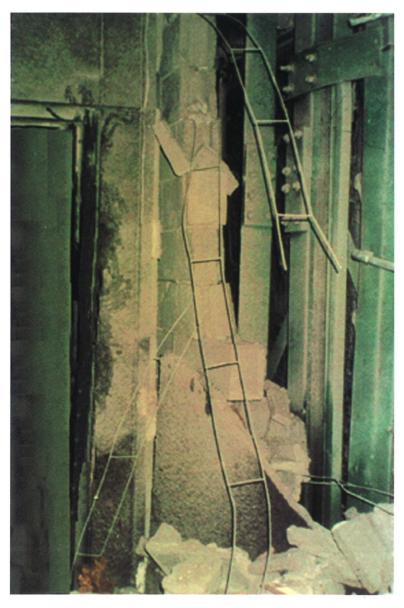
All suspended ceiling panels and much of the ductwork located above these panels were removed by blast effects. In the core area, concrete masonry partition walls were heavily damaged, particularly on the first three floors. Figure 1-27 shows damage to one of the elevator shafts in the core area near Column Line 16.

Figure 1-27 Damage to masonry wall at elevator shaft in Murrah Building.

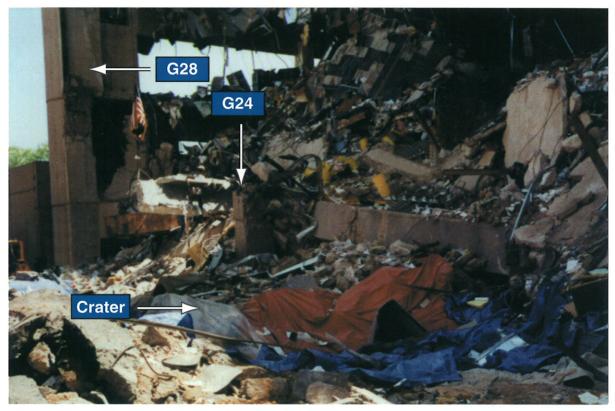
Figure 3-1 Bomb crater (covered by tarp).

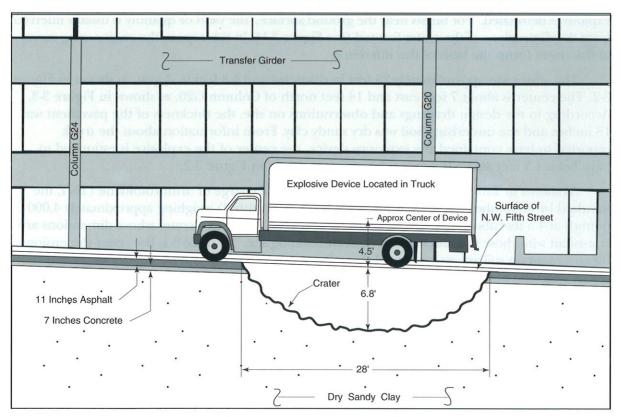
Figure 3-2 Approximate dimensions of crater at north face of Murrah Building.

Condition	Depth (feet)	Diameter (feet)
4,000 Pounds of TNT on Massive Concrete	2.6	13
4,000 Pounds of TNT on Dry Sandy Clay	8.5	31
4,000 Pounds of TNT — 18 Inches of Pavement on Soil	7.2	27
Measured at Murrah Building	6.8	28

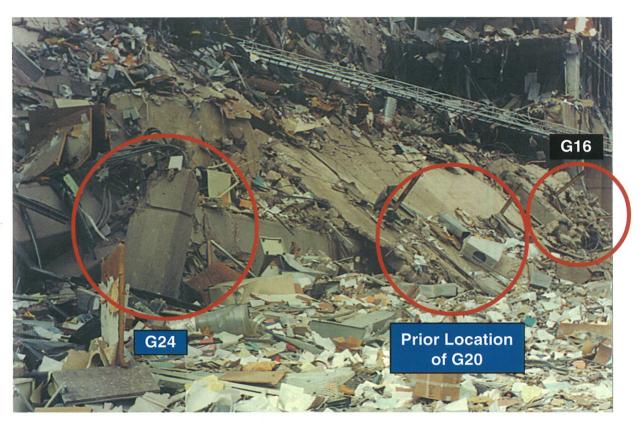
Figure 3-12 Damage at Column Line G.

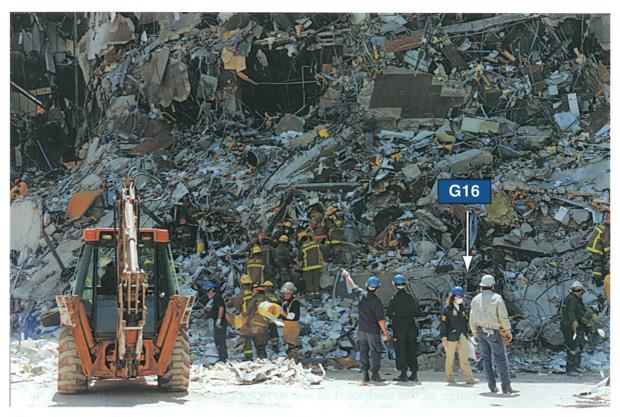
Figure 3-13 View of damage at north face of Murrah Building.

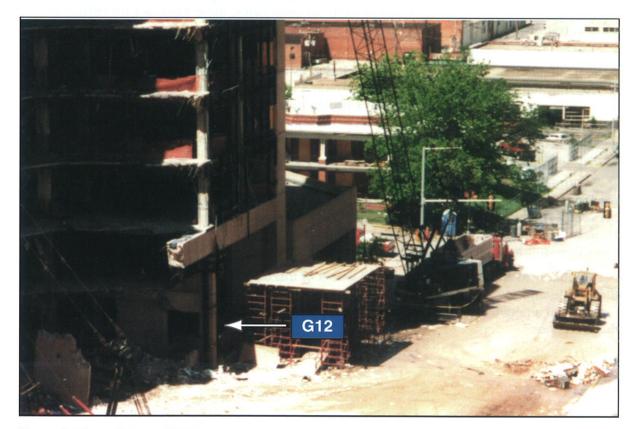
However, Column G12 did endure the direct blast effects of the bomb. It was located at a slant range of 89 feet as indicated in Table 3-2. Here, the loading was 115 pounds per square inch. The associated response is only 0.1 times the capacity to resist. The results of this analysis are consistent with the intact condition of this column after the bombing, as shown in Figure 3-14.

Figure 3-14 Column G12 intact.

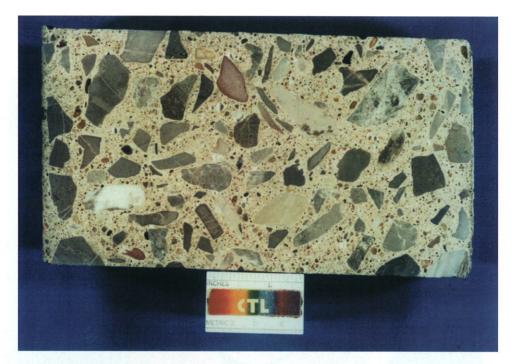
FIG. 3 LAPPED LONGITUDINAL CROSS SECTION OF CORE 7B SHOES AGGREGATE SIZE, SHAPE, GRADATION AND DISTRIBUTION OF THE CEMENT PASTE. NO MAJOR CRACKS ARE VISIBLE IN THE SAMPLE.

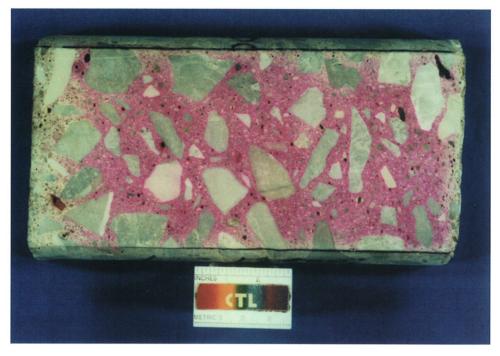
FIG. 4 OPPOSING, SAWCUT SIDE OF THE SLICE OF CONCRETE SHOWN IN FIG.3, AFTER THE SURFACE WAS TREATED WITH A pH INDICATOR SOLUTION. NONCARBONATED PASTE IS SHOWN STAINED A Magenta COLOR, WHILE LOWER pH CARBONATED PASTE REMAINS UNSTAINED.
