FULL SCALE ARENA
GSA TEST REPORT

MODEL DESIGNATION: Solar Gard® Armorcoat® Safety & Security Films

Test Report No.: F5228.02-801-12

- 2.1 Introduction
 Solar Gard retained Architectural Testing, Inc. (ATI) to conduct a full scale arena blast test on their Solar Gard Armorcoat window film per the requirements of GSA-TS01-2003.

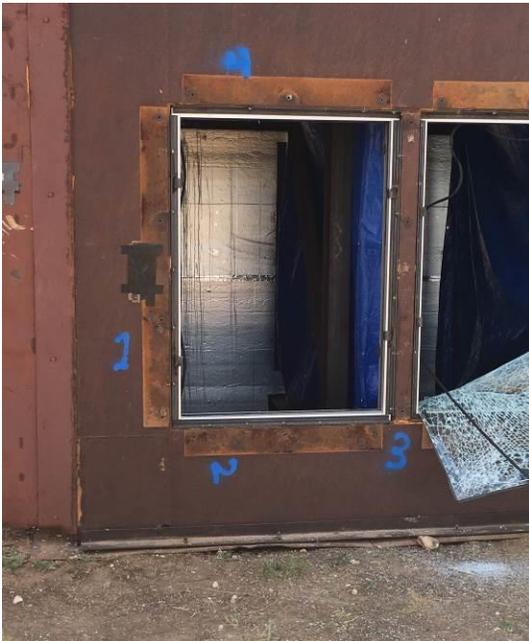
The system performed consistent with a "Performance Condition 3b." The lite of the specimen yielded during the air blast pressure loading. The glass was pulled from the test frame to the exterior. The pullout of the unit allowed fragments to enter the test chamber no further than 10 feet from the specimen.

Figure C.3: Specimen 1
Post-Blast Condition

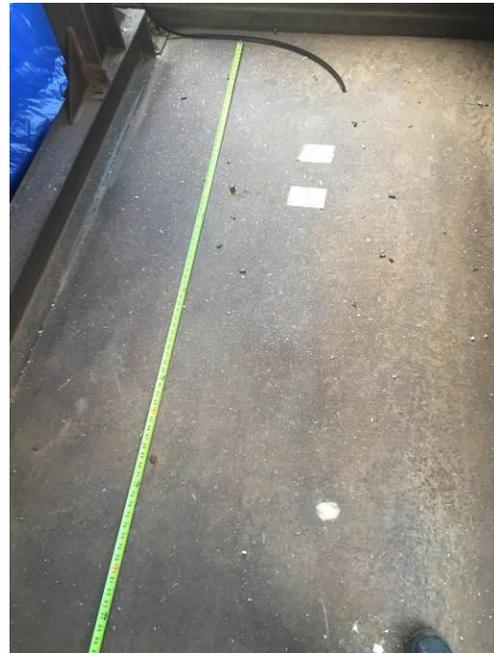
Figure C.4: Specimen 1
Glazing Fragments

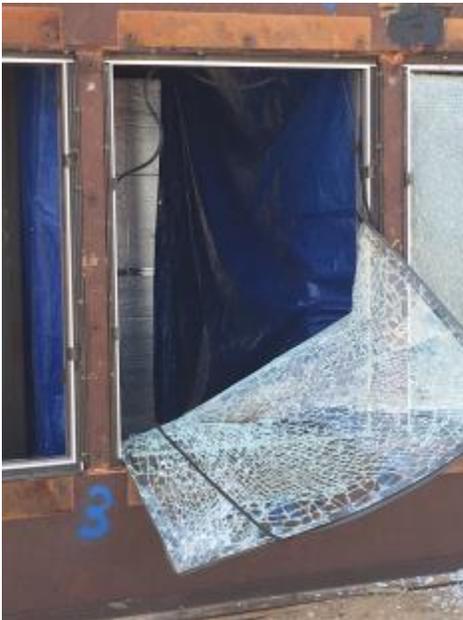
- 11.1.2 Specimen 2- Mono Annealed
 The system performed consistent with a “Performance Condition 3b.” The lite of the specimen fractured during air blast pressure loading. The glazing remained in the opening. The pullout of the unit caused glass to enter the test chamber no further than 10 feet from the specimen.

Figure C.7: Specimen 2
Post-Blast Condition

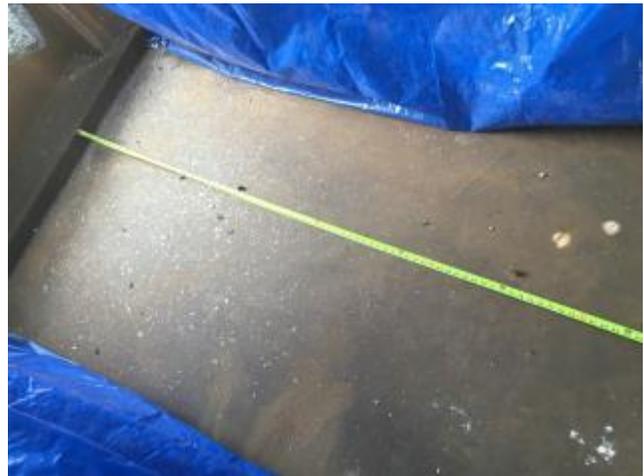
Figure C.8: Specimen 2
Glazing Fragments

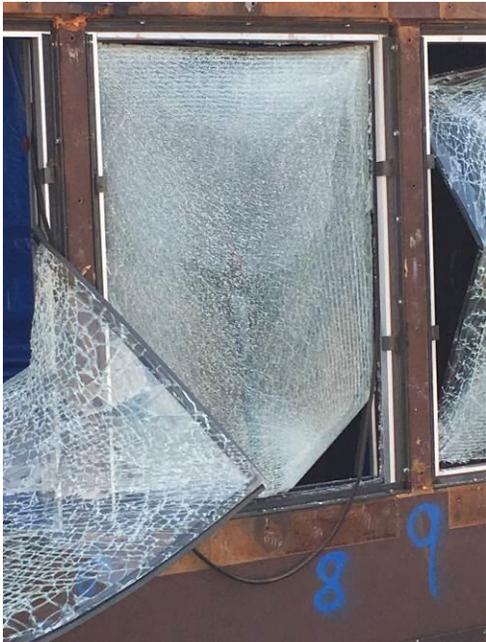
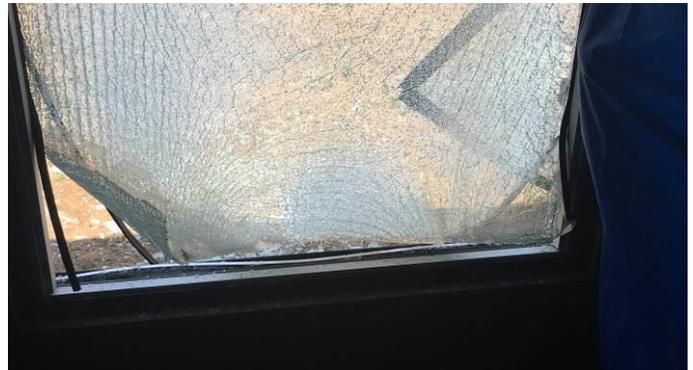
- 11.1.3 Specimen 3- IGU Tempered
 The system performed consistent with a “Performance Condition 3b.” The exterior lite and interior lite of the specimen fractured during the air blast pressure loading. The glazing remained in the opening. The pullout of the unit allowed fragments to enter the test chamber no further than 10 feet from the specimen.

Figure C.11: Specimen 3
Post-Blast Condition

Figure C.12: Specimen 3
Post-Blast Condition

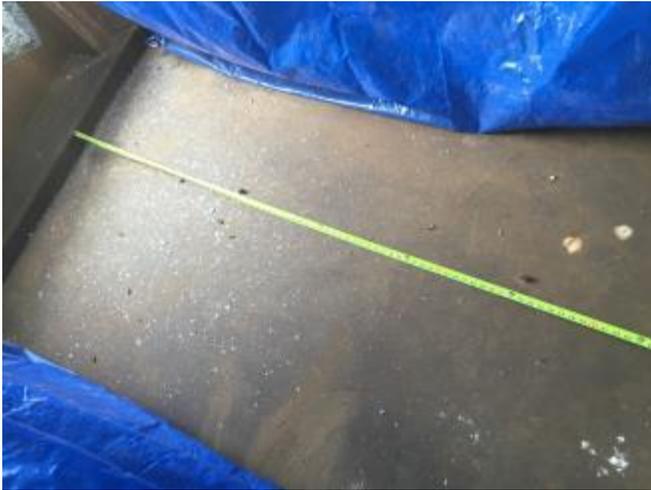
Figure C.13: Specimen 3
Glazing Fragments

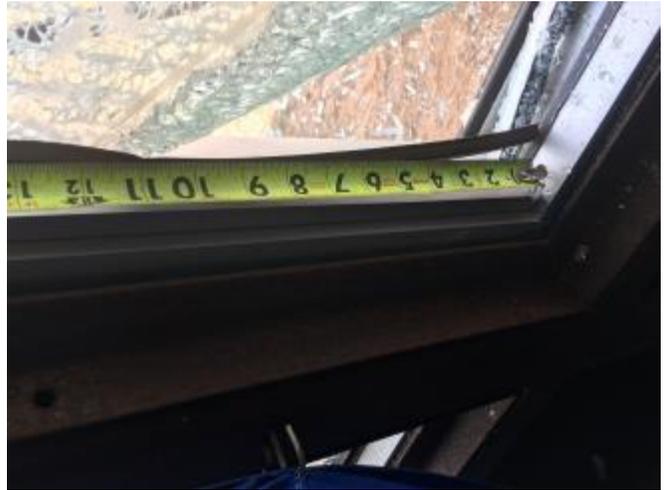
Figure C.14: Specimen 3
Edge Pullout

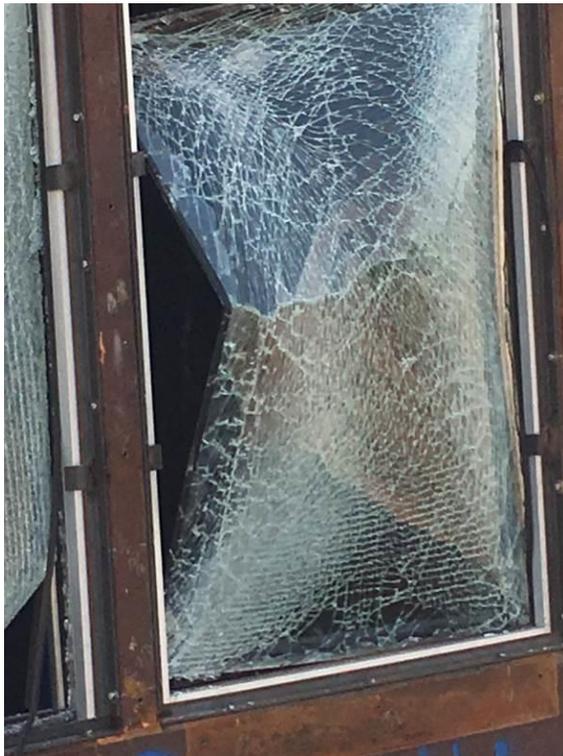
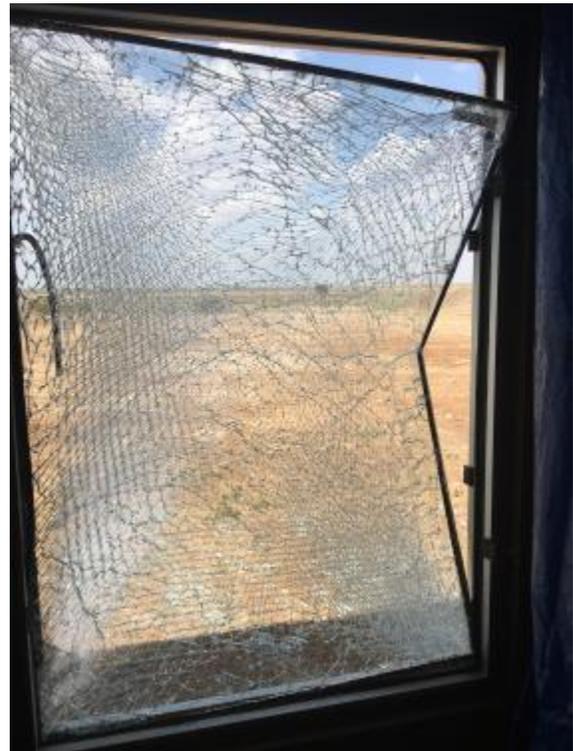
- 11.1.4 Specimen 4- IGU Annealed
 The system performed consistent with a “Performance Condition 3a.” The exterior lite and interior lite of the specimen fractured during air blast pressure loading. No fragments entered the test chamber.

Figure C.17: Specimen 4
Post-Blast Condition

Figure C.18: Specimen 4
Post Blast Conditions
