Beijing Capital International Airport, Beijing, China

Installation Summary

Solar Gard Alleviates Solar Heat Headache at Beijing Capital International Airport

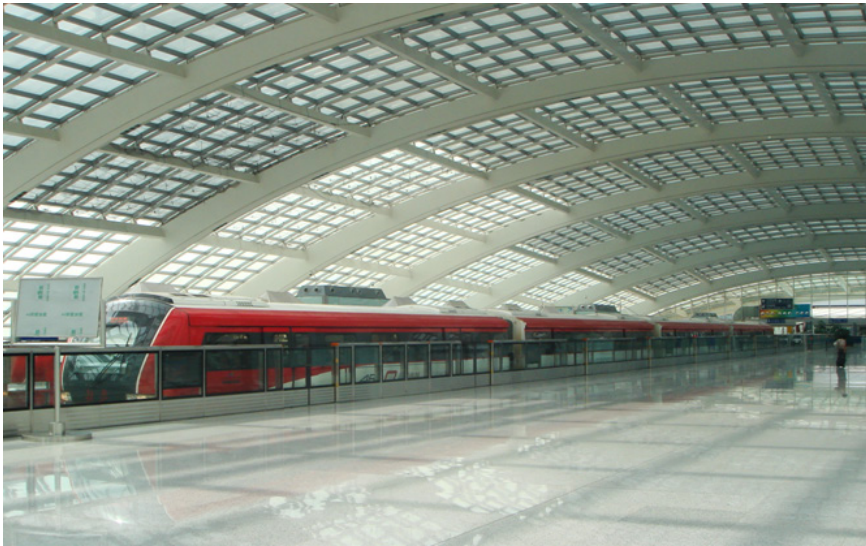
Terminal 3, Beijing Capital International Airport Solar Gard® Sterling 20 alleviated uncomfortable temperatures

Terminal 3 suffered a compounded heat problem. The wide glass ceiling allowed the sun to stream directly in, intensely heating the area and Beijing's summer temperatures typically linger around 90°F. Air conditioning was inadequate because of the giant space. The combination of solar heat intake through the glass ceiling, Beijing's

To access the massive arched ceiling, the team built a rope spider web-like scaffolding system to maneuver through the air. Because the work was

performed at night during low traffic, it took one month to complete. Solar Gard Sterling 20 was installed on 30,000 square meters of Terminal 3. It blocks 99 % of the ultraviolet rays and rejects 76% of solar heat intake.
