## **Performance Test Report**

**Report No.**: C6549.04-401-44

SAINT-GOBAIN PERFORMANCE PLASTICS SOLAR GARD® San Diego, California

**PRODUCT TYPE**: 100 micron (4 mil) Polyester Film **SERIES/MODEL**: Solar Gard Sentinel 4 mil

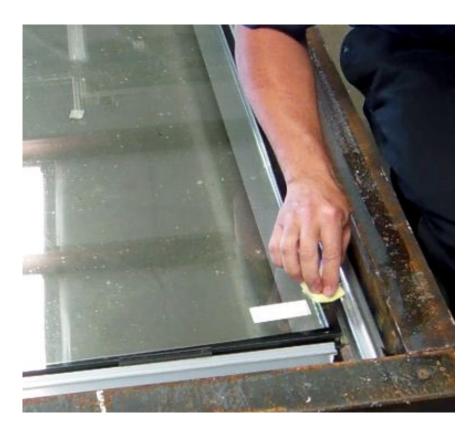
Photo#1
Specimen #1
Pentagon Flexible Membrane Specimen
Perimeter of All Film Edges Treated with an
Adhesion Promoter (3M 4298)

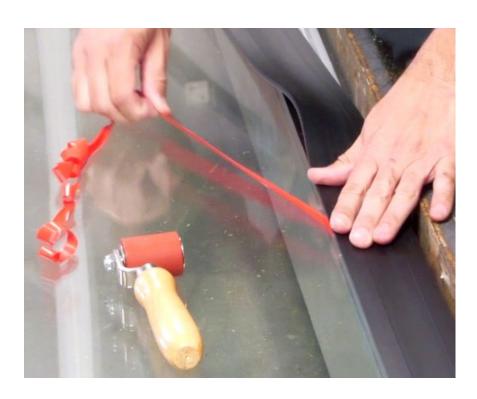
Photo#2
Specimen #1
Pentagon Flexible Membrane Specimen
Pentagon Flexible Membrane Applied to the Film Edges;
Bridging the Two Opposing Glazing Pockets and Secured by
14.3 mm (9/16") wide Double-sided Tape that was Fabricated on the Two Outside Edges of the Pentagon Flexible Membrane

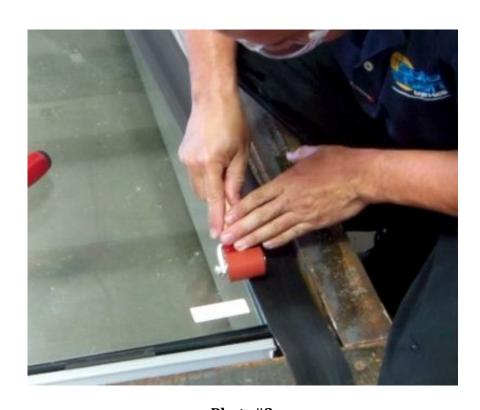
Photo#3
Specimen #1
Pentagon Flexible Membrane Specimen
Pentagon Flexible Membrane Secured in Place to the Film,
by Applied Pressure Using Application Tools.
Application Tool #1

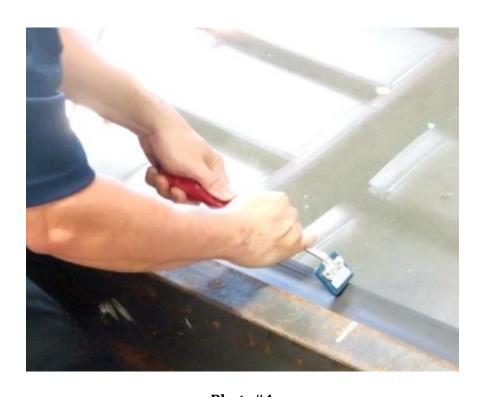
Photo#4
Specimen #1
Pentagon Flexible Membrane Specimen
The Pentagon Flexible Membrane Secured in Place
to the Film by Applied Pressure Using Application Tools.
Application Tool #2

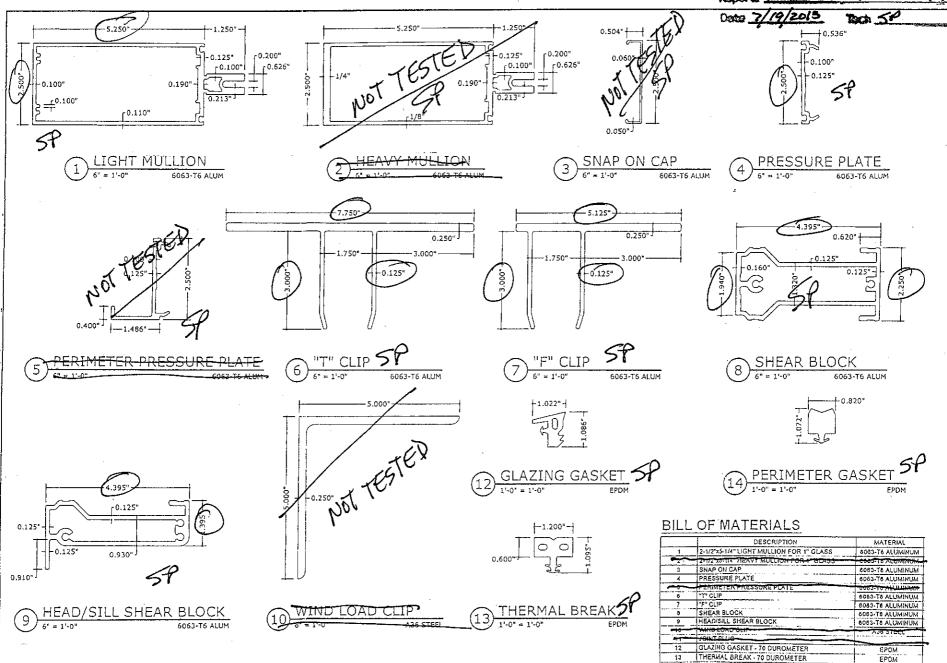
Test sample complies with the wide details. Deviations are noted.

PERIMETER GASKET - 70 DUROMETER
