The Oklahoma City Bombing:

IMPROVING BUILDING PERFORMANCE
THROUGH MULTI-HAZARD MITIGATION

In May 1995, the Federal Emergency Management Agency (FEMA) deployed a Building Performance Assessment Team (BPAT) composed of American Society of Civil Engineers (ASCE) and Federal Government engineers to investigate damage caused by the malevolent bombing of the Alfred P. Murrah Federal Building.

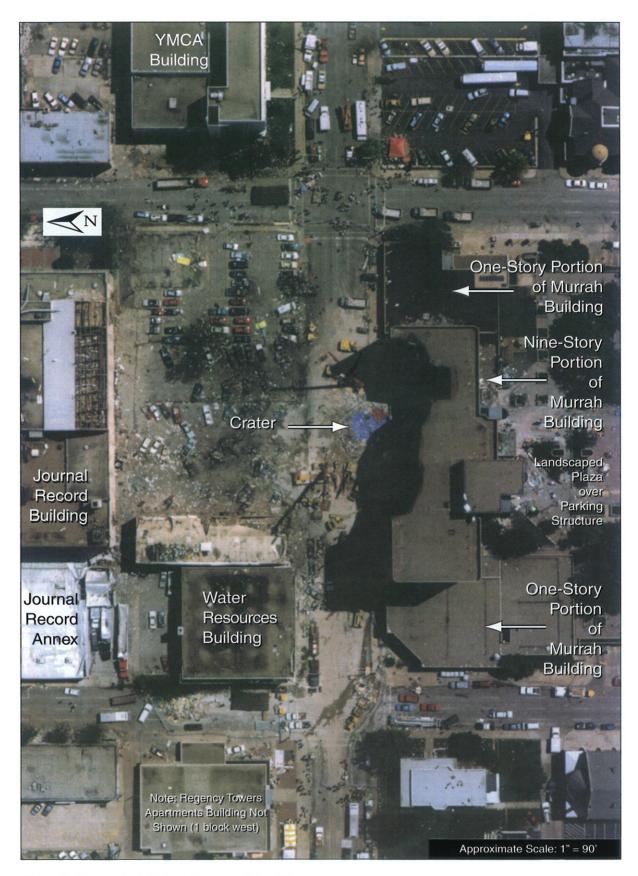
Figure 1-13 Aerial view of damaged buildings.

A one-story light-metal steel building just west of the main Journal Record building housed the presses. This building, referred to as the Journal Record Annex (see Figure 1-13), was badly damaged, sustaining severe deformations of roof and wall members (see Figure 1-21). Also, an unreinforced masonry wall on the north side of the Annex was damaged. This wall was quickly demolished and removed to reduce the hazard to workers. All of the damage to the Annex was attributable to blast effects.

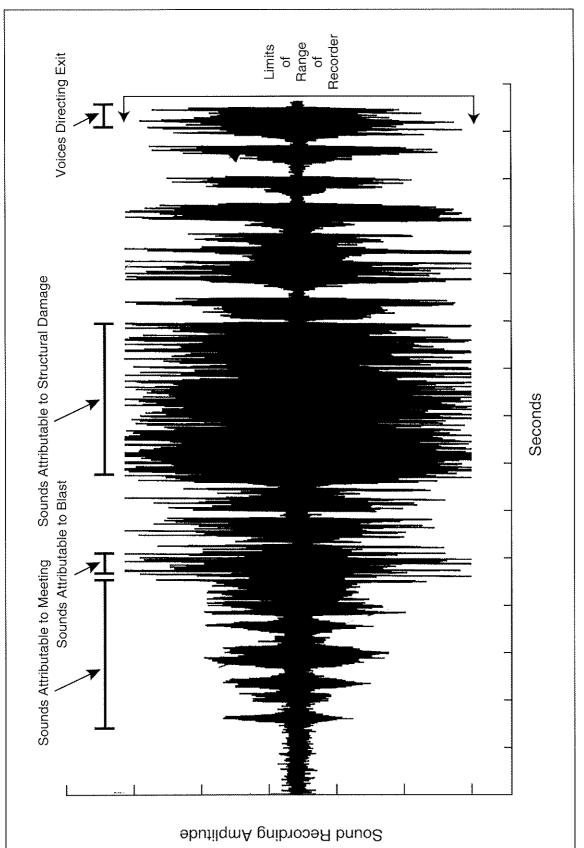
At 9 a.m. on April 19, 1995, a hearing on water rights was convened in the Water Resources building, which is located at the northeast corner of North Harvey Avenue and N.W. Fifth Street, less than block from the site of the explosion (see Figure 1-3). An audio tape recorder, used to document the hearing, was started approximately 2 minutes before the blast occurred.

Analysis of tape recording from Water Resources building.

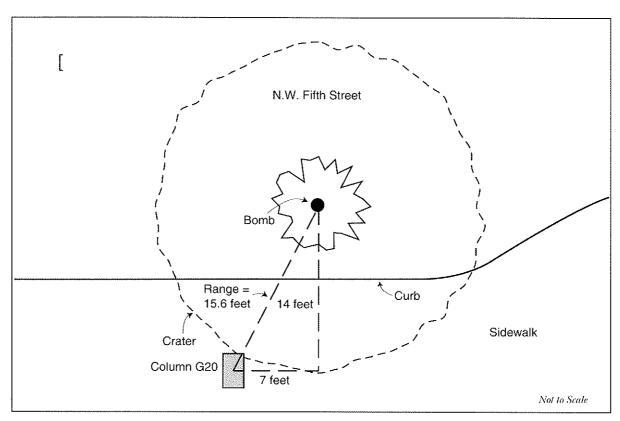
The crater was approximately 28 feet in diameter and 6.8 feet in depth, as shown in Figure 3-2. The center is about 7 feet east and 14 feet north of Column G20, as shown in Figure 3-3. According to the design drawings and observations on site, the thickness of the pavement was 18 inches and the underlying soil was dry sandy clay. From information about the truck reported to have contained the explosive device, the center of the explosive is estimated to have been 4.5 feet above the ground surface, as shown in Figure 3-2.

Figure 3-3 Proximity of Column G20 to location of bomb (plan view).

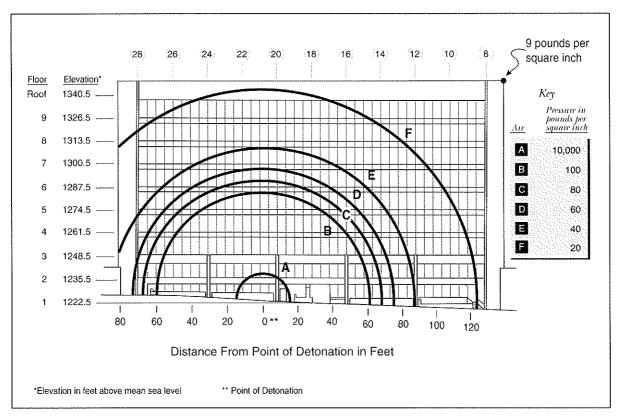
Figure 3-5 Peak overpressures on north elevation of nine-story portion of Murrah Building.

Of particular interest is the loading on the nine-story portion of the Murrah Building. The peak overpressures on the north elevation are shown in Figure 3-5. These range from a maximum of over 10,000 pounds per square inch at the point closest to the detonation to a minimum of 9 pounds per square inch at the upper west corner, with an equivalent uniform value of approximately 140 pounds per square inch. While these pressures are extremely large, they act for a limited duration as shown in Figure 3-6. The duration ranges from a maximum in the upper west corner to a minimum at the point closest to the blast and has an equivalent uniform value for a triangular pulse of about 5 milliseconds.

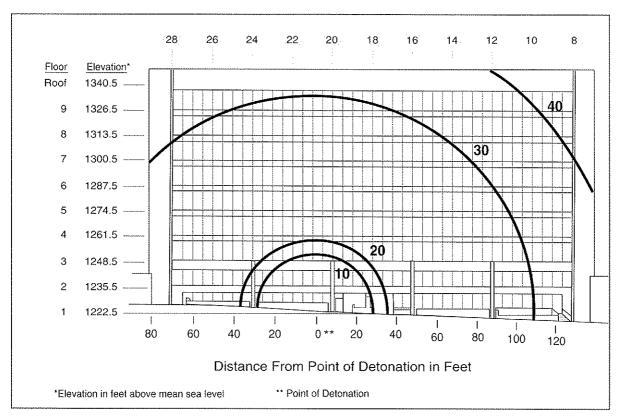
Figure 3-6 Duration of loading (in milliseconds) on north elevation of nine-story portion of Murrah Building.

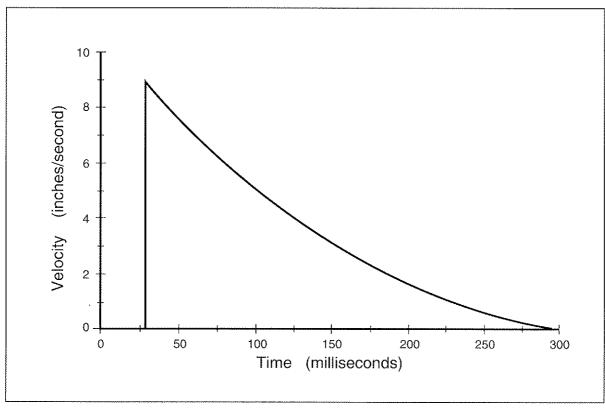
Any explosive detonation near the ground surface causes a ground shock motion in addition to the airblast loading. For the surface detonation of 4,000 pounds of TNT, the free-field motion at the center of the building is shown in Figure 3-7. There is a rapid rise after arrival to a peak value of 9 inches per second, followed by a gradual decay over the next 270 milliseconds. In comparison to the extreme airblast loading, this ground shock motion is of little consequence to the structure.

Figure 3-7 Free field ground shock at center of Murrah Building.

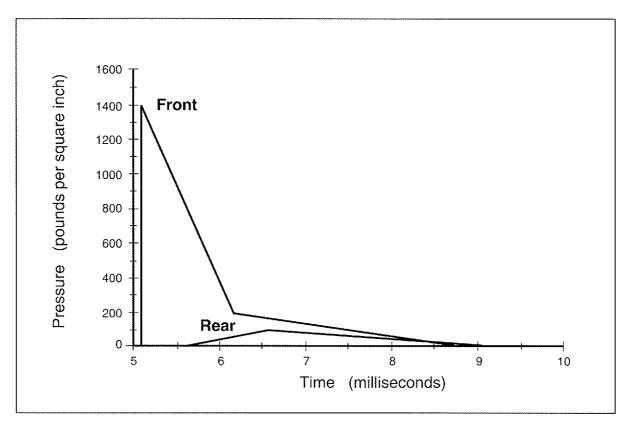
Figure 3-10 Blast loading of Column G24.

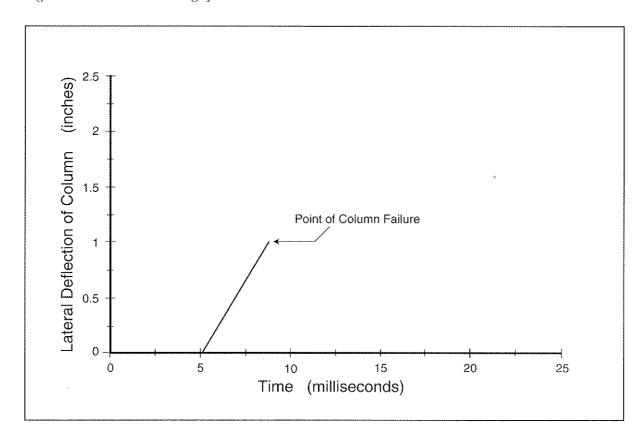
Figure 3-11 Blast response of Column G24 at midpoint (second-floor elevation).

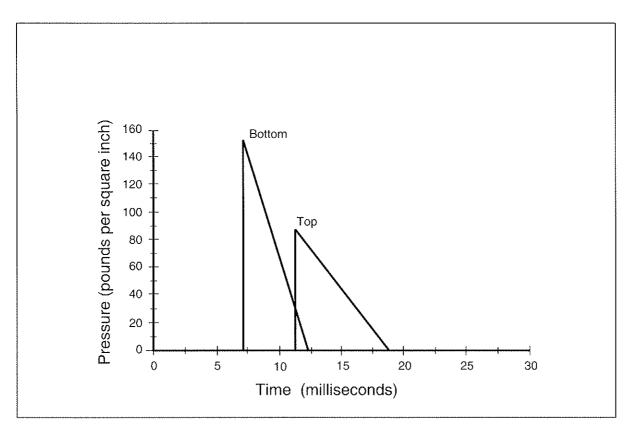
Figure 3-17 Blast loading of fifth-floor slab between Column Lines 20 and 22.

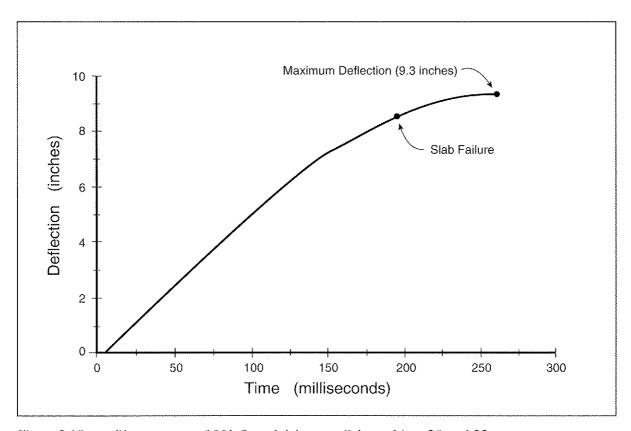
Figure 3-18 Blast response of fifth-floor slab between Column Lines 20 and 22.

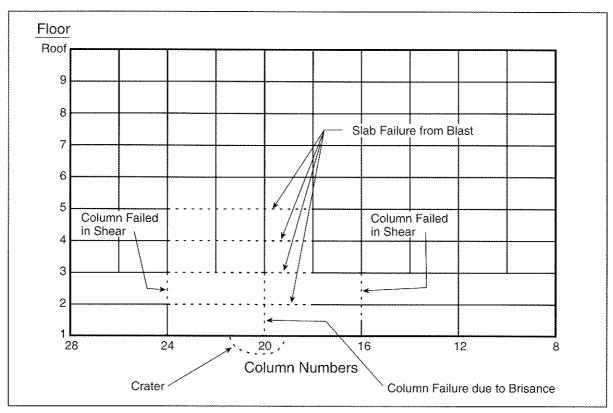
Figure 3-19 Schematic of blast response, north elevation of nine-story portion of Murrah Building at Column Line G.

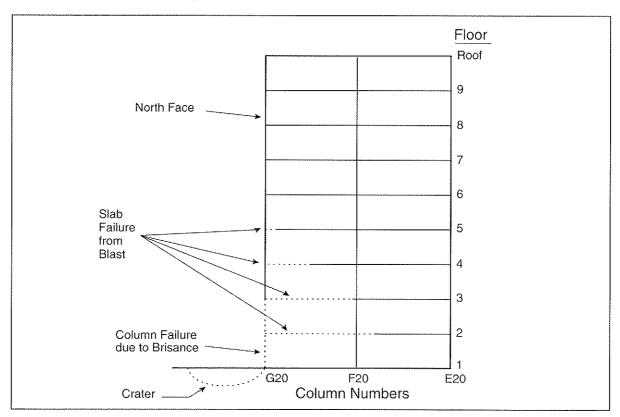
Figure 3-20 approximates the inward extent of this directly induced slab failure. It assumes that the distance of blast propagation is the range to determine the net upward loading. The results show a penetration of failure to 40 feet at the second floor, which diminishes to zero at the sixth floor.

Figure 3-20 Cross section of nine-story portion of Murrah Building showing blast response of slabs.

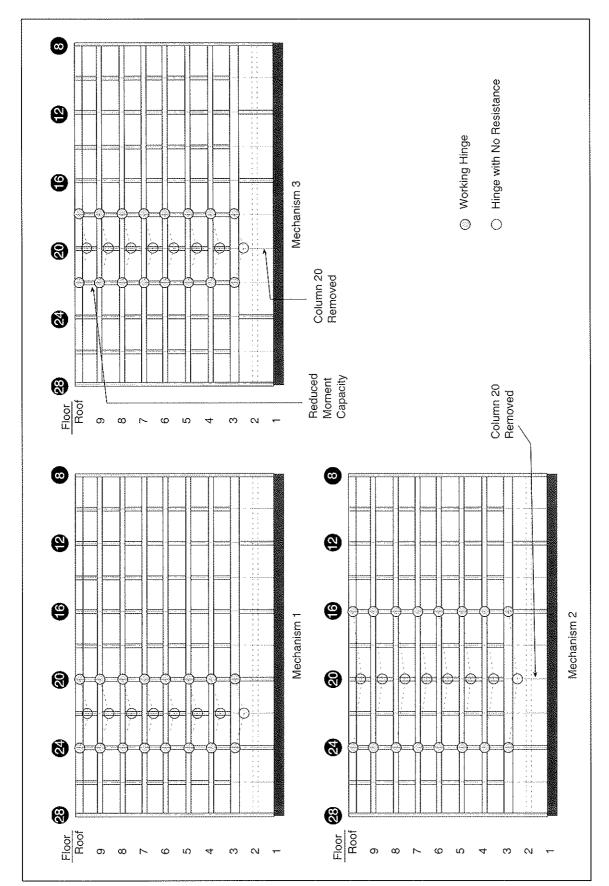
The unit load calculated for Mechanism 1, which refers to the intact structure, confirms that the as-built structure had adequate flexural strength for code-prescribed gravity loads.

Collapse Mechanisms I, 2, and β (north elevation of nine-story portion of MurrahBuilding). Figure 3-30

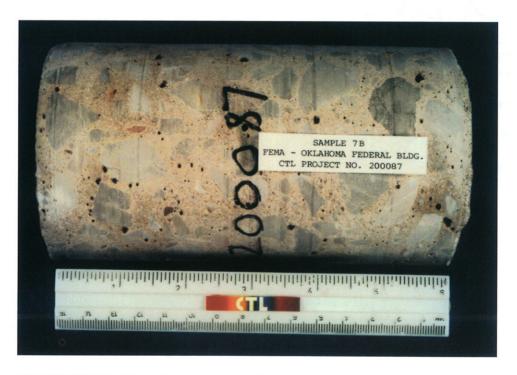
One concrete core designated as "7B" (Fig. 1) was received from Dr. W. Gene Corley, Vice President, CTL. The core represents a portion of a larger concrete fragment (Fig. 2) reportedly taken from remains of the Alfred P. Murrah Federal Building in Oklahoma City. Petrographic examination of the core was requested by Dr. Corley to describe the constituents and general condition of the concrete.

FIG. 1 END VIEW AND SIDE OF CORE 7B, AS RECEIVED FOR EXAMINATION.

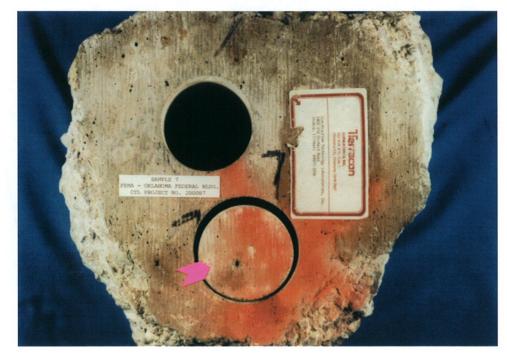
FIG. 2 VIEW OF THE LARGE FRAGMENT OF CONCRETE (SAMPLE NO.7) AFTER TWO CORES WERE DRILLED. SAMPLE 7B, SELECTED FOR PETROGRAPHIC EXAMINATION, IS MARKED BY AN ARROW,. THE OTHER CORE WAS REMOVED AND FORWARDED TO CTL PHYSICAL TESTING FOR TESTING.
