FULL SCALE ARENA
ASTM F 1642 TEST REPORT

MODEL DESIGNATION: Solar Gard® Armorcoat® Safety & Security Films

Report No.: B7294.01-801-12
Test Date: 10/13/10
Report Date: 03/02/11
Test Report Retention End Date: 03/02/15

- 2.1 Introduction
 Solar Gard retained Architectural Testing, Inc. (ATI) to conduct a full scale arena blast test on their Solar Gard Armorcoat window film per the requirements of ASTM F1642-04 and UFC 4-010-01.

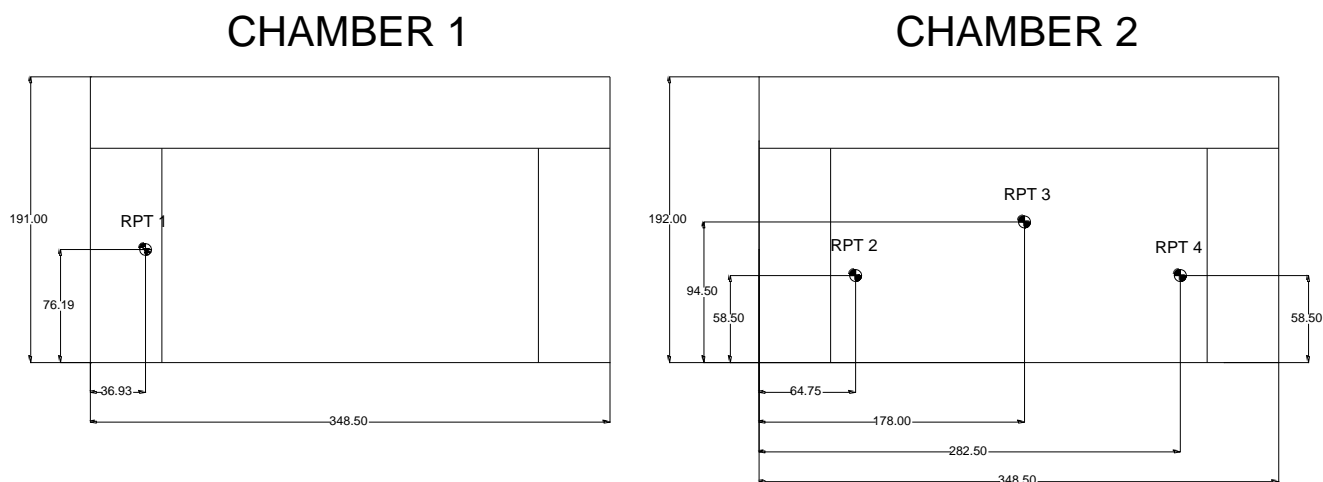
Figure 1: Reflected Pressure Transducer Locations

Figure 1 shows the locations of the reflected pressure transducers on the two (2) single span reaction chambers that were placed at a standoff of 159 feet.

ATI placed eight (8) reflected pressure transducers on the single span blast reaction chambers to measure the reflected blast pressure time histories acting on the surface of the mock-up. The reflected pressure transducer locations are given in Figure 1 and Figure 8.

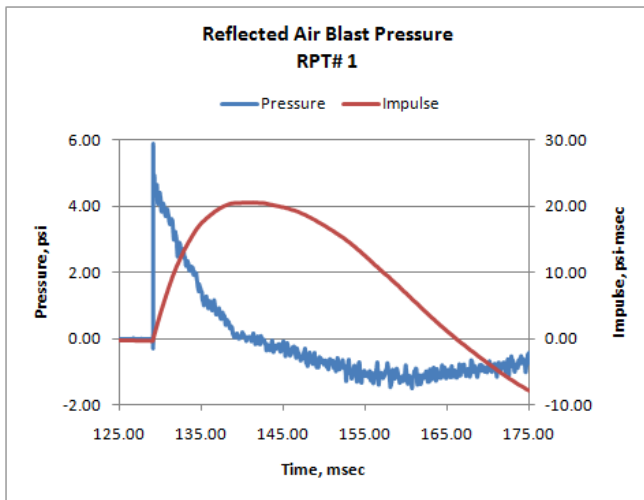
Figure 2: Reflected Air Blast Pressure (RPT #1)

Table 6 summarizes the reflected blast pressure and positive phase impulse for each pressure transducer location. Figures 2 through 5 provide the reflected air blast pressure (red) and impulse (blue) time histories graphically.

Air Blast Parameter	RPT 1	RPT 2	RPT 3	RPT 4	Average
Peak Pressure, (psi)	5.874	5.579	5.992	5.089	5.633
Positive Phase Impulse, (psi-msec)	26.17	22.86	28.97	23.65	25.55 ¹
Positive Phase Duration (msec)	13.22	10.86	15.50	11.62	12.80

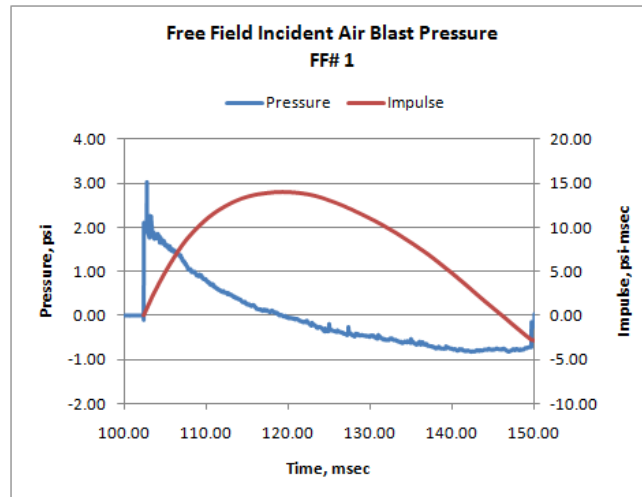
Figure 6: Free Field Incident Air Blast Pressure Time Histories

Table 7 provides the results obtained from the free field pressure transducer, and Figure 6 provides the free field incident air blast pressure time histories.

Blast Parameter	FF 1
Peak Air Blast Pressure (psi)	3.04
Peak Positive Phase Impulse (psi-msec)	13.98

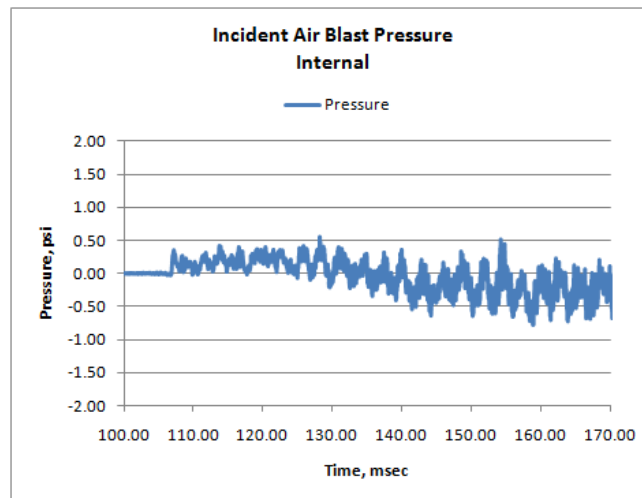
Figure 7: Internal Air Blast Pressure Time History

ATI measured a maximum internal air blast pressure of approximately 0.56 psi inside the air blast reaction chamber during air blast pressure loading. Figure 7 provides a graph of the internal air blast pressure time history.

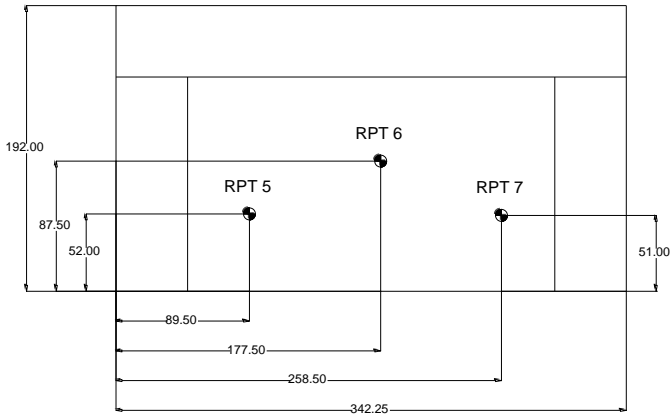
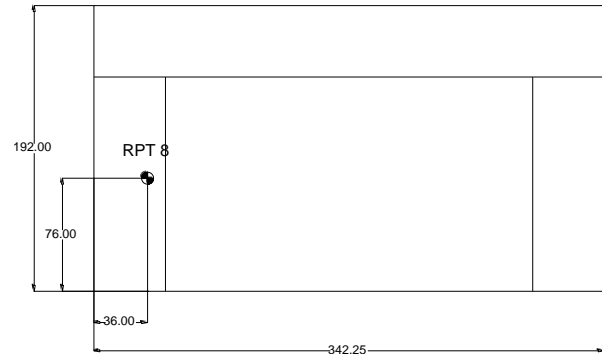
Figure 8: Reflected Pressure Transducer Locations

Figure 8 shows the locations of the reflected pressure transducers on the two (2) single span reaction chambers that were placed at a standoff of 124 feet.

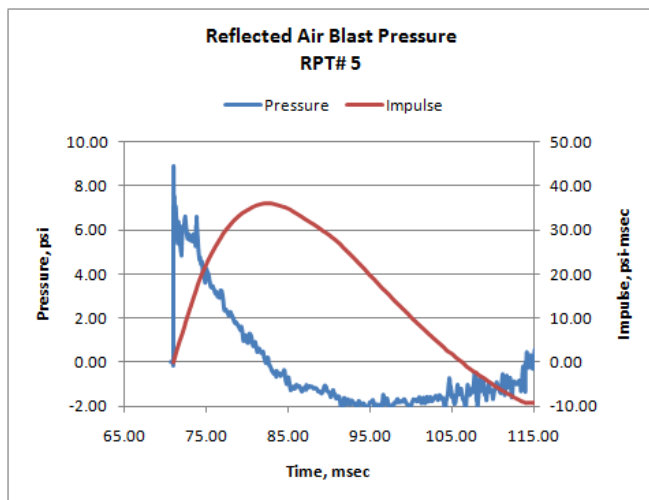
Figure 9: Reflected Air Blast Pressure (RPT #5)

Table 8 summarizes the reflected blast pressure and positive phase impulse for each pressure transducer location. Figures 9 through 12 provide the reflected air blast pressure (red) and impulse (blue) time histories graphically.

Air Blast Parameter	RPT 5	RPT 6	RPT 7	RPT 8	Average
Peak Pressure, (psi)	8.893	7.720	8.895	8.164	8.529
Positive Phase Impulse, (psi-msec)	36.15	38.81	36.59	37.52	36.79 ¹
Positive Phase Duration (msec)	11.65	13.04	11.31	9.613	11.21

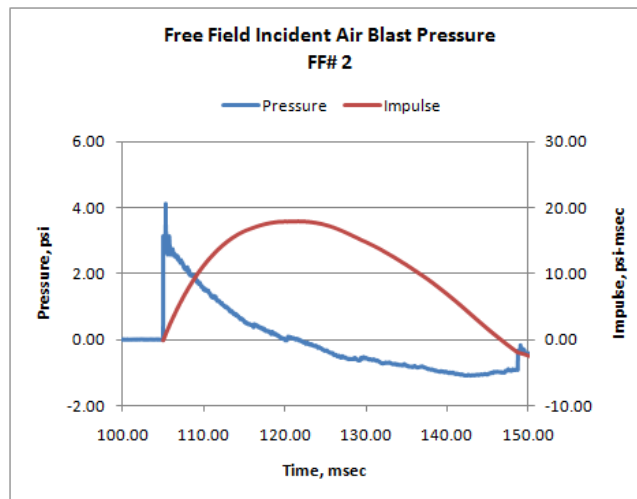
Figure 13: Free Field Incident Air Blast Pressure Time Histories

Table 9 provides the results obtained from the free field pressure transducers, and Figure 13 provides the free field incident air blast pressure time histories.

Blast Parameter	FF 1
Peak Incident Air Blast Pressure (psi)	4.21
Peak Positive Phase Impulse (psi-msec)	20.91

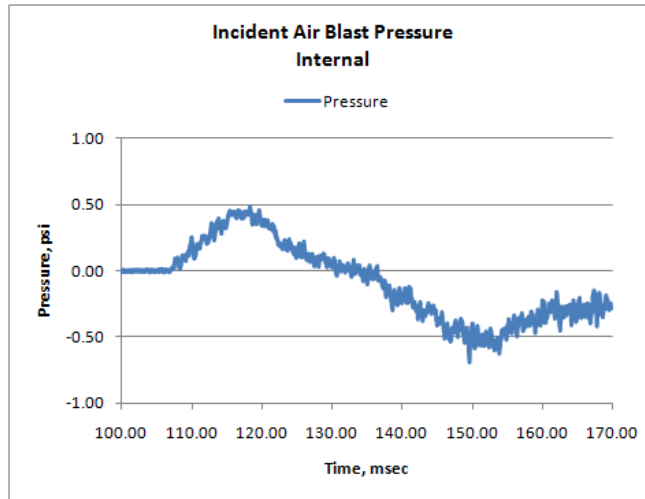
Figure 14: Internal Incident Air Blast Pressure Time History

ATI measured a maximum internal incident air blast pressure of approximately 0.48 psi inside the air blast reaction chamber during air blast pressure loading. Figure 14 provides a graph of the internal air blast pressure time history.

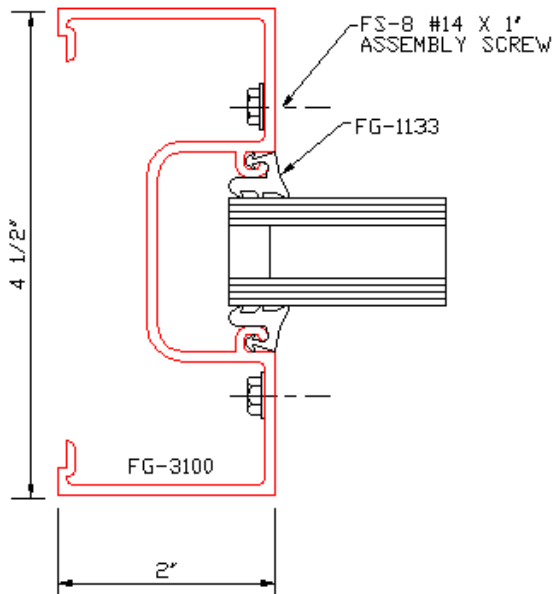
- a. Dual pane frame detail
 - i. Jamb detail

The Head (Part #FG-3103) and Jamb (Part #FG-3100) were used. The Glass Stop (Part #FG-3144) was snap fit to the Sill (Part #FG-3161).

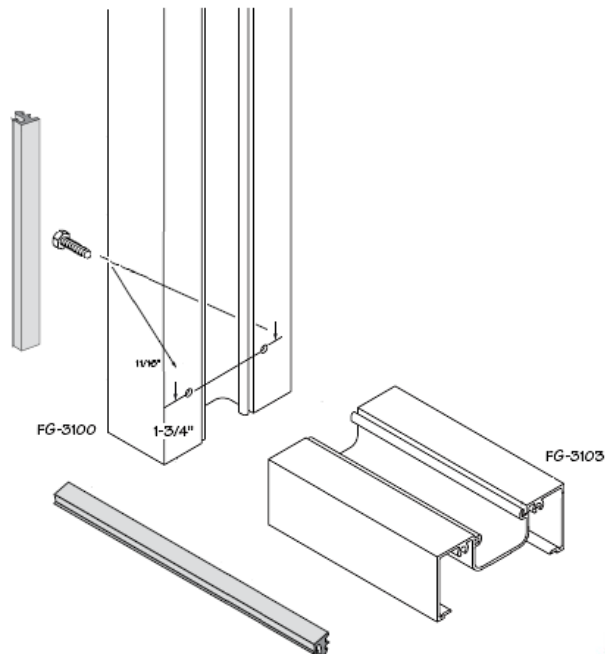
iv. Assembly

The vertical members ran through, while the horizontal member ends were square cut, butted and mechanically fastened to each vertical member using two (2) FS-8 #14 x 1" assembly screws.

- d. Corner assembly – Frames were all square cut and assembled using fastener FS-8 #14 (1").
- e. Glass bite – Each window unit had a glass bite of 3/8 inch.
- f. Exterior glazing method – The following glazing material was used to glaze the exterior portion of the glass.

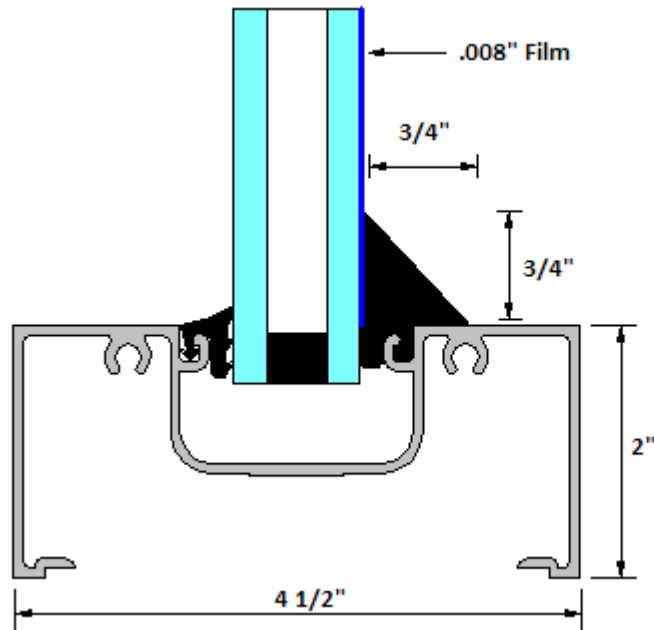
i. 8mil Film on Dual Pane Glass

- g. Interior glazing method – Solar Gard attached the Solar Gard Armorcoat film with GE SCS2000 SilPruf* structural sealant. The wet glaze attachment consisted of a 3/4" bead on the interior side of the glazing to adhere the film to the window frame as shown in Section II. Specifications for the GE SCS2000 SilPruf* can be reviewed in Appendix D.
- h. Test buck installation method – Architectural Testing Inc. installed the window frames into the test bucks using 1-3/4" x 1-3/4" angles sandwiching the specimens with 2" clips on the verticals of the angle 12" from the top and bottom. The details of this installation are in Section III.

A continuous 3/4" x 3/4" bead of GE SCS2000 SilPruf* silicone sealant & adhesive to adhere the film to the window frame was used.

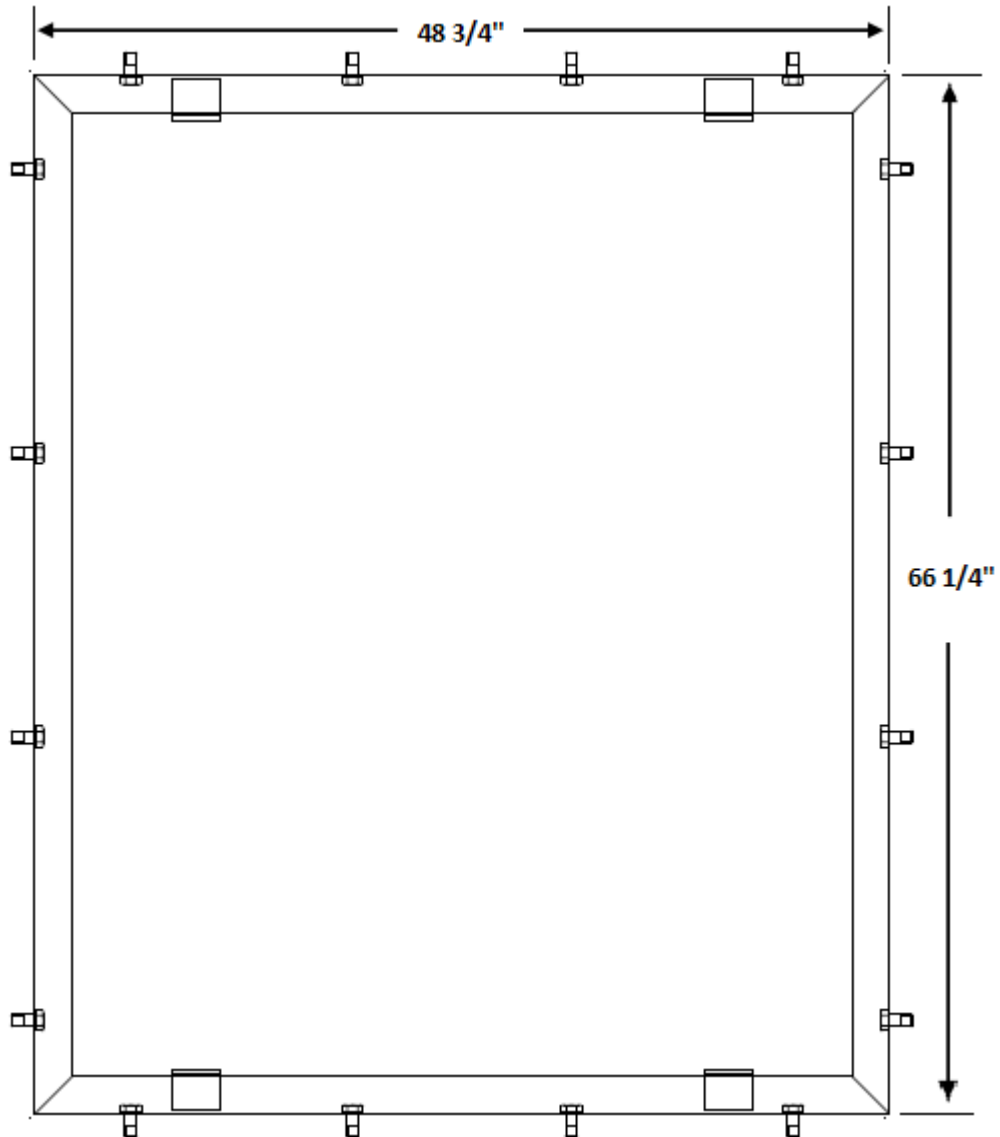
- a. Test Buck & Frame Installation Detail
 - i. Chamber 1

Exterior mounting - The exterior angles were mechanically fastened to the steel opening using one (1) 9/16" x 2" HH Gr. 5 Bolt. Hardware spacing: 2" from the end and 10" on center thereafter. 2" clips were mechanically fastened on the verticals of the angle 12" from the top and bottom were installed using (1) 9/16" x 2" HH Gr. 5 Bolt

Interior mounting - The interior angles were welded to the steel opening using two (2) 1/4" fillet welds. 2" clips were mechanically fastened on the verticals of the angle 12" from the top and bottom were installed using (1) 9/16" x 2" HH Gr. 5 Bolt

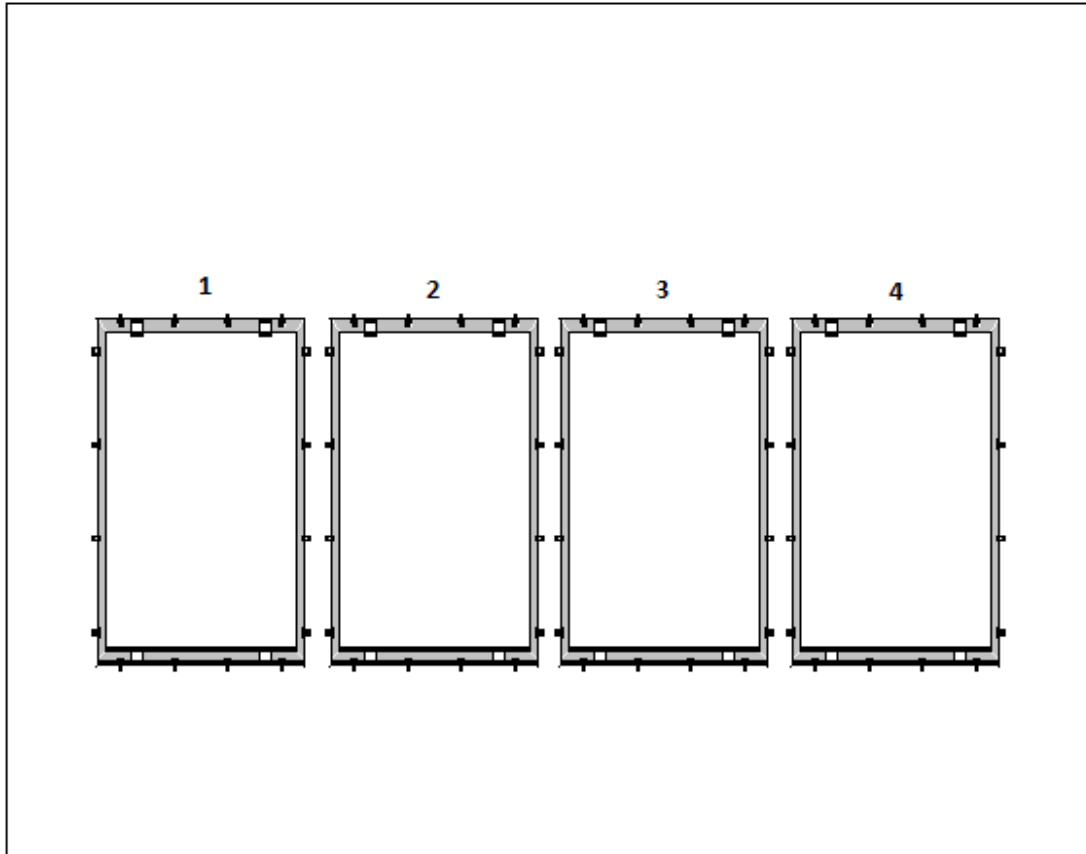
- a. Chamber drawings
 - i. Chamber 1

Chamber 1	Window	Glazing Type	Assembled Unit Size	Film Type	Attachment Type
	1	IGU Annealed-Type III	48 3/4" x 66 1/4"	Solar Gard Armorcoat 8mil	Wet Glazed
	2	IGU Annealed-Type III	48 3/4" x 66 1/4"	Solar Gard Armorcoat 8mil	Wet Glazed
	3	IGU Annealed-Type III	48 3/4" x 66 1/4"	Solar Gard Armorcoat 8mil	Wet Glazed
	4	IGU Annealed-Type III	48 3/4" x 66 1/4"	Solar Gard Armorcoat 8mil	Wet Glazed

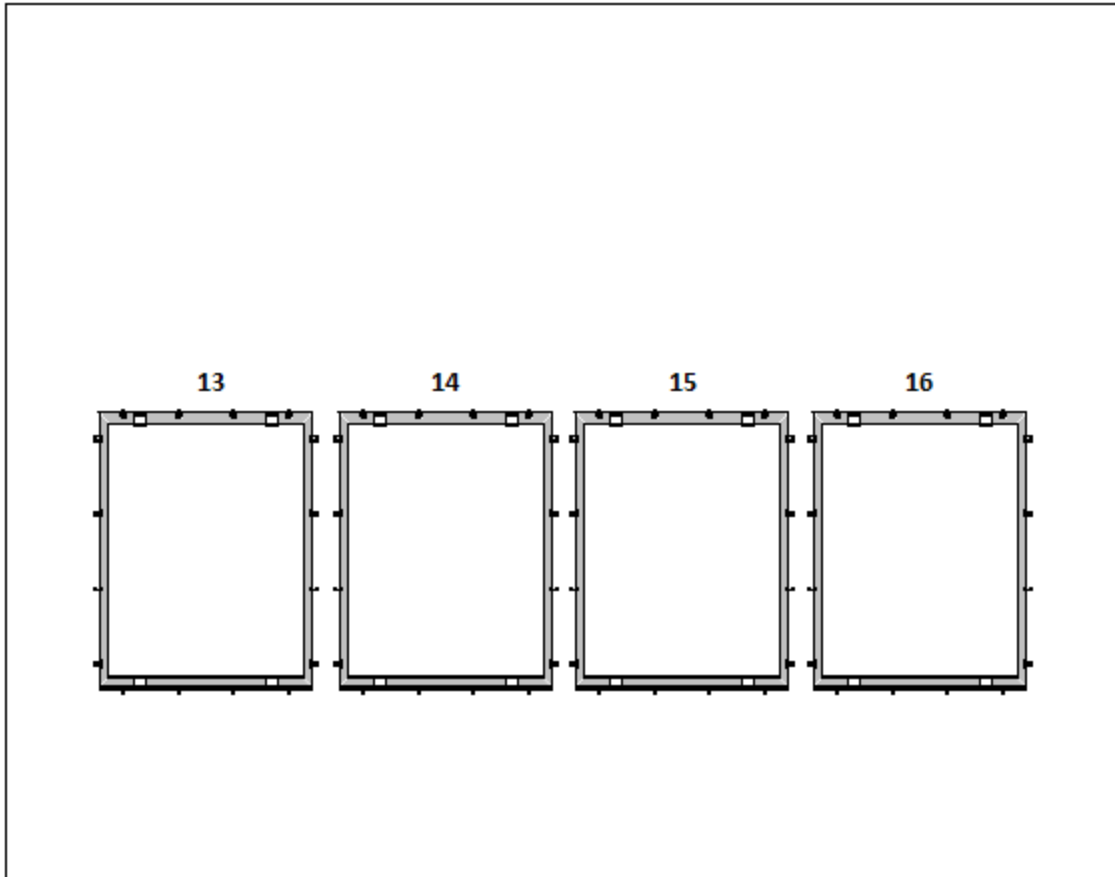
ii. Chamber 4

Window	Glazing Type	Assembled Unit Size	Film Type	Attachment Type
13	IGU Tempered-Type IV	36 1/2" x 44 3/4"	Solar Gard Armorcoat 8mil	Wet Glazed
14	IGU Tempered-Type IV	36 1/2" x 44 3/4"	Solar Gard Armorcoat 8mil	Wet Glazed
15	IGU Tempered-Type IV	36 1/2" x 44 3/4"	Solar Gard Armorcoat 8mil	Wet Glazed
16	IGU Tempered-Type IV	36 1/2" x 44 3/4"	Solar Gard Armorcoat 8mil	Wet Glazed

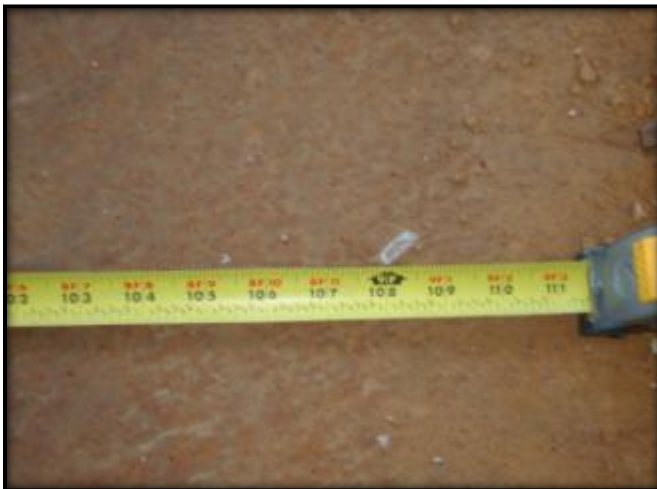
Figure C.7: Specimen 2 Fragment

All four (4) of the specimens' inboard and outboard lites fractured during air blast pressure loading. Specimen 2's film tore producing one (1) qualifying fragment past the 1 meter mark. Zero (0) perforations or fragment indents were observed anywhere in the vertical witness panel. Table 10 provides a summary of the glazing response during air blast pressure loading.

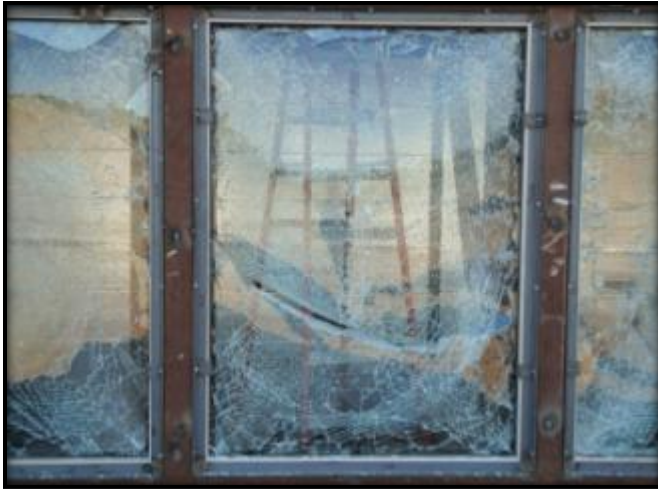
Figure C.9: Specimen 2 External
Post-Blast Condition

Specimen #	Temp. °F	Fracture Status		Comments
		Inboard	Outboard	
1	71.5	Yes	Yes	No tears or pullout observed.
2	72.0	Yes	Yes	28" tear observed, no pullout.
3	70.0	Yes	Yes	No tears or pullout observed.
4	72.5	Yes	Yes	No tears or pullout observed.

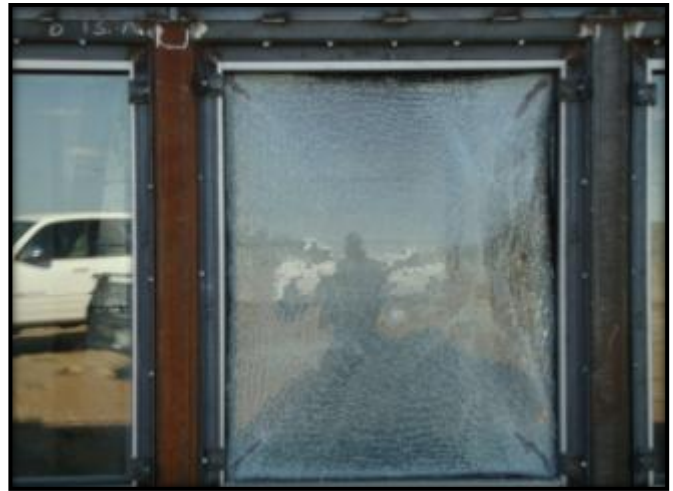
Figure C.22: Specimen 14 External Post-Blast Condition

Specimen 14's inboard and outboard lites fractured during air blast pressure loading. The film showed no signs of tearing and retained the glazing within the frame. Specimens 13, 15 and 16's inboard and outboard lites did not fracture during air blast pressure loading. No qualifying fragment and zero (0) perforations or fragment indents were observed anywhere in the vertical witness panel. Table 11 provides a summary of the glazing response during air blast pressure loading.

The system performed consistent with a "No Hazard." The exterior and interior lites of Specimen 14 fractured during air blast pressure loading. The glazing was fully retained in the test frames. No breach and no material were lost from the interior surface of the specimens during air blast pressure loading.

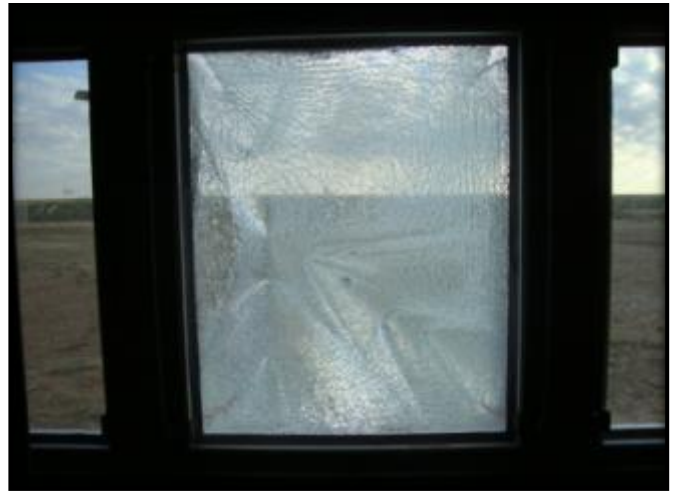
Figure C.26: Specimen 14 Internal
Post-Blast Condition
